Evaluation of Damage to a Historic Masonry Building in Nepal through Comparison of Dynamic Characteristics before and after the 2015 Gorkha Earthquake

Aiko Furukawa^{1*}, Junji Kiyono¹, Rishi Ram Parajuli¹, Hari Ram Parajuli² and Kenzo Toki³

¹Department of Urban Management, Graduate School of Engineering, Kyoto University, Kyoto, Japan, ²National Reconstruction Authority, Government of Nepal, Kathmandu, Nepal, ³Institute of Disaster Mitigation for Urban Cultural Heritage, Ritsumeikan University, Kyoto, Japan

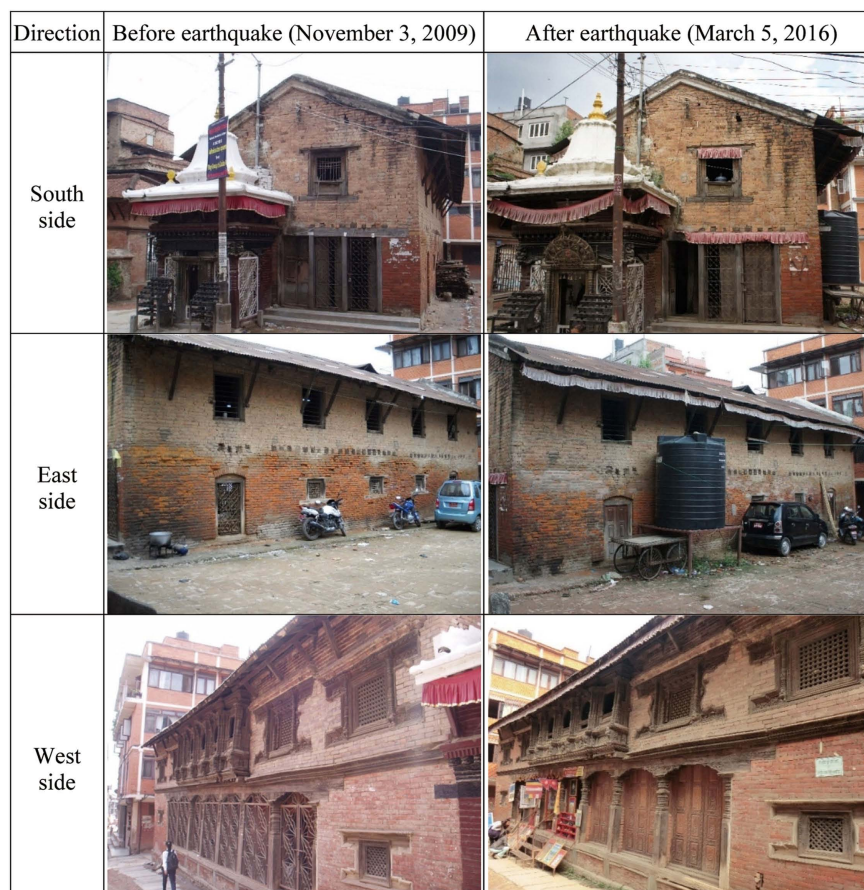
Figure 3 shows the comparison of the building appearance from the outside before and after the 2015 Gorkha earthquake. The pictures on the left were taken before the earthquake in November of 2009, and the pictures on the right were taken after the earthquake in March of 2016. Although many minor cracks in mortar were visible during the survey in March of 2016, most of those minor cracks were already present in the photo taken in 2009, and it was difficult to find out new cracks from the outside of the building. Then visual inspection of the cracks inside the building was carried out. Several cracks were found on the both ground and first floors as shown in Figure 5. Although no comparable photos taken prior to the earthquake are present, those cracks appeared to be new. In Figure 5, some walls resemble concrete walls, but they are brick walls covered with plaster. In addition to the cracks shown in Figure 5, several cracks were found on the ceiling of the GF and the timbers were seemingly deteriorated on the RF. Nevertheless, it was difficult to distinguish the damage

FIGURE 3 | Appearance of building before and after the 2015 Gorkha earthquake.

that already existed before the earthquake through the visual inspection.

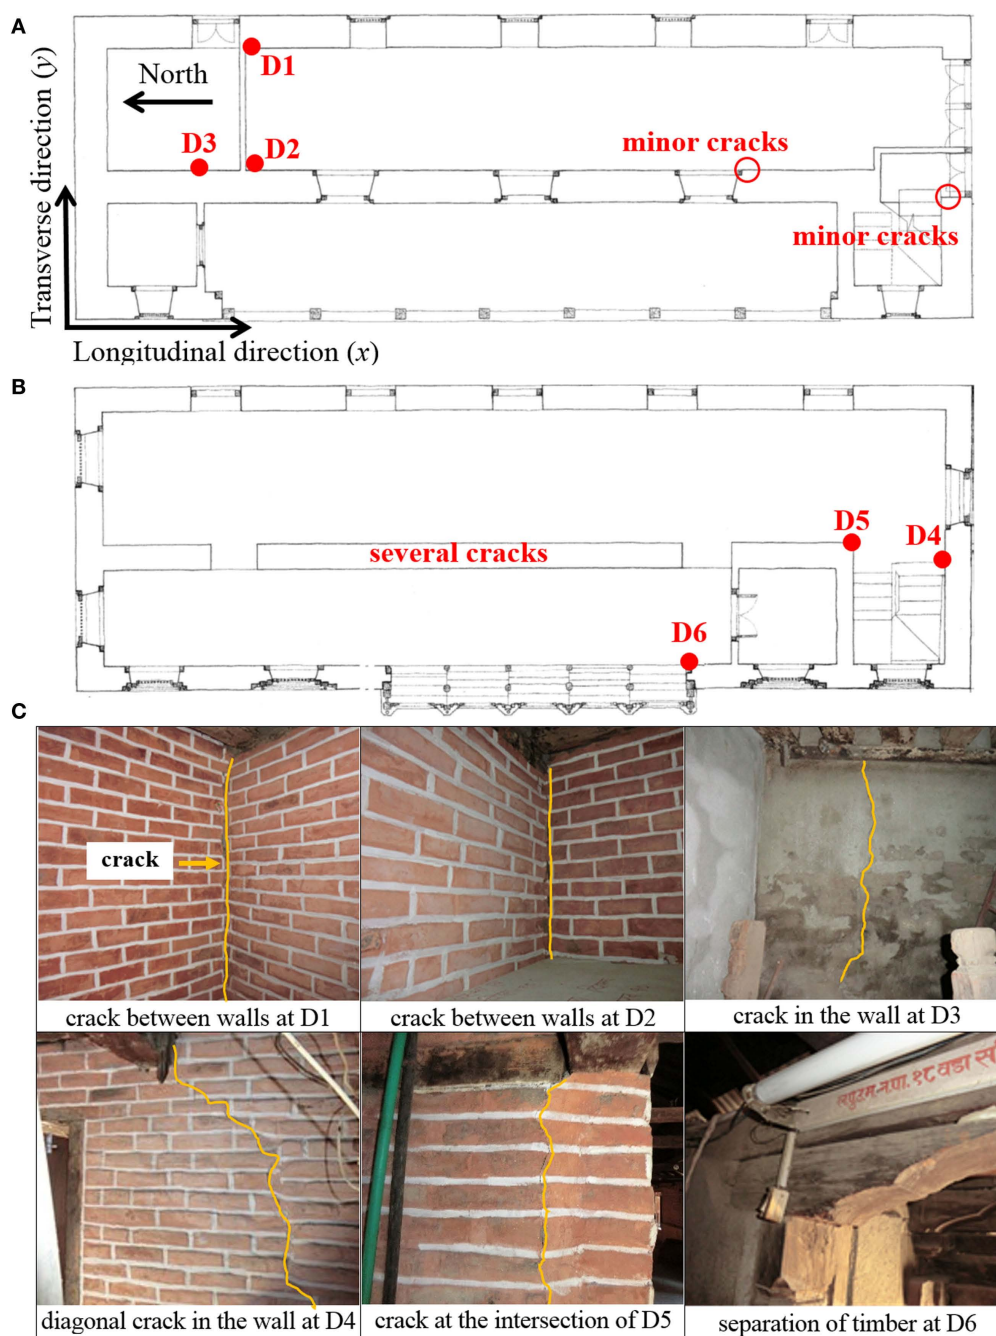
FIGURE 5 | Location and photographs of cracks found in the building after the 2015 Gorkha earthquake. **(A)** Location of cracks in the ground floor. **(B)** Location of cracks in the 1st floor. **(C)** Photographs of cracks found inside the building.

with the places where actual cracks were found in the post-earthquake inspection of the target building as already shown in **Figure 5C**. In this section, the distribution of shear strain is selected since it is found that large shear strain takes place where the actual cracks were found in the post-earthquake inspection.

It was found that the natural frequencies of the lowest 8 modes decreased by 3.46 to 11.86%, indicating structural damage. In a post-earthquake inspection of the building, several cracks were found on the ground and first floors.

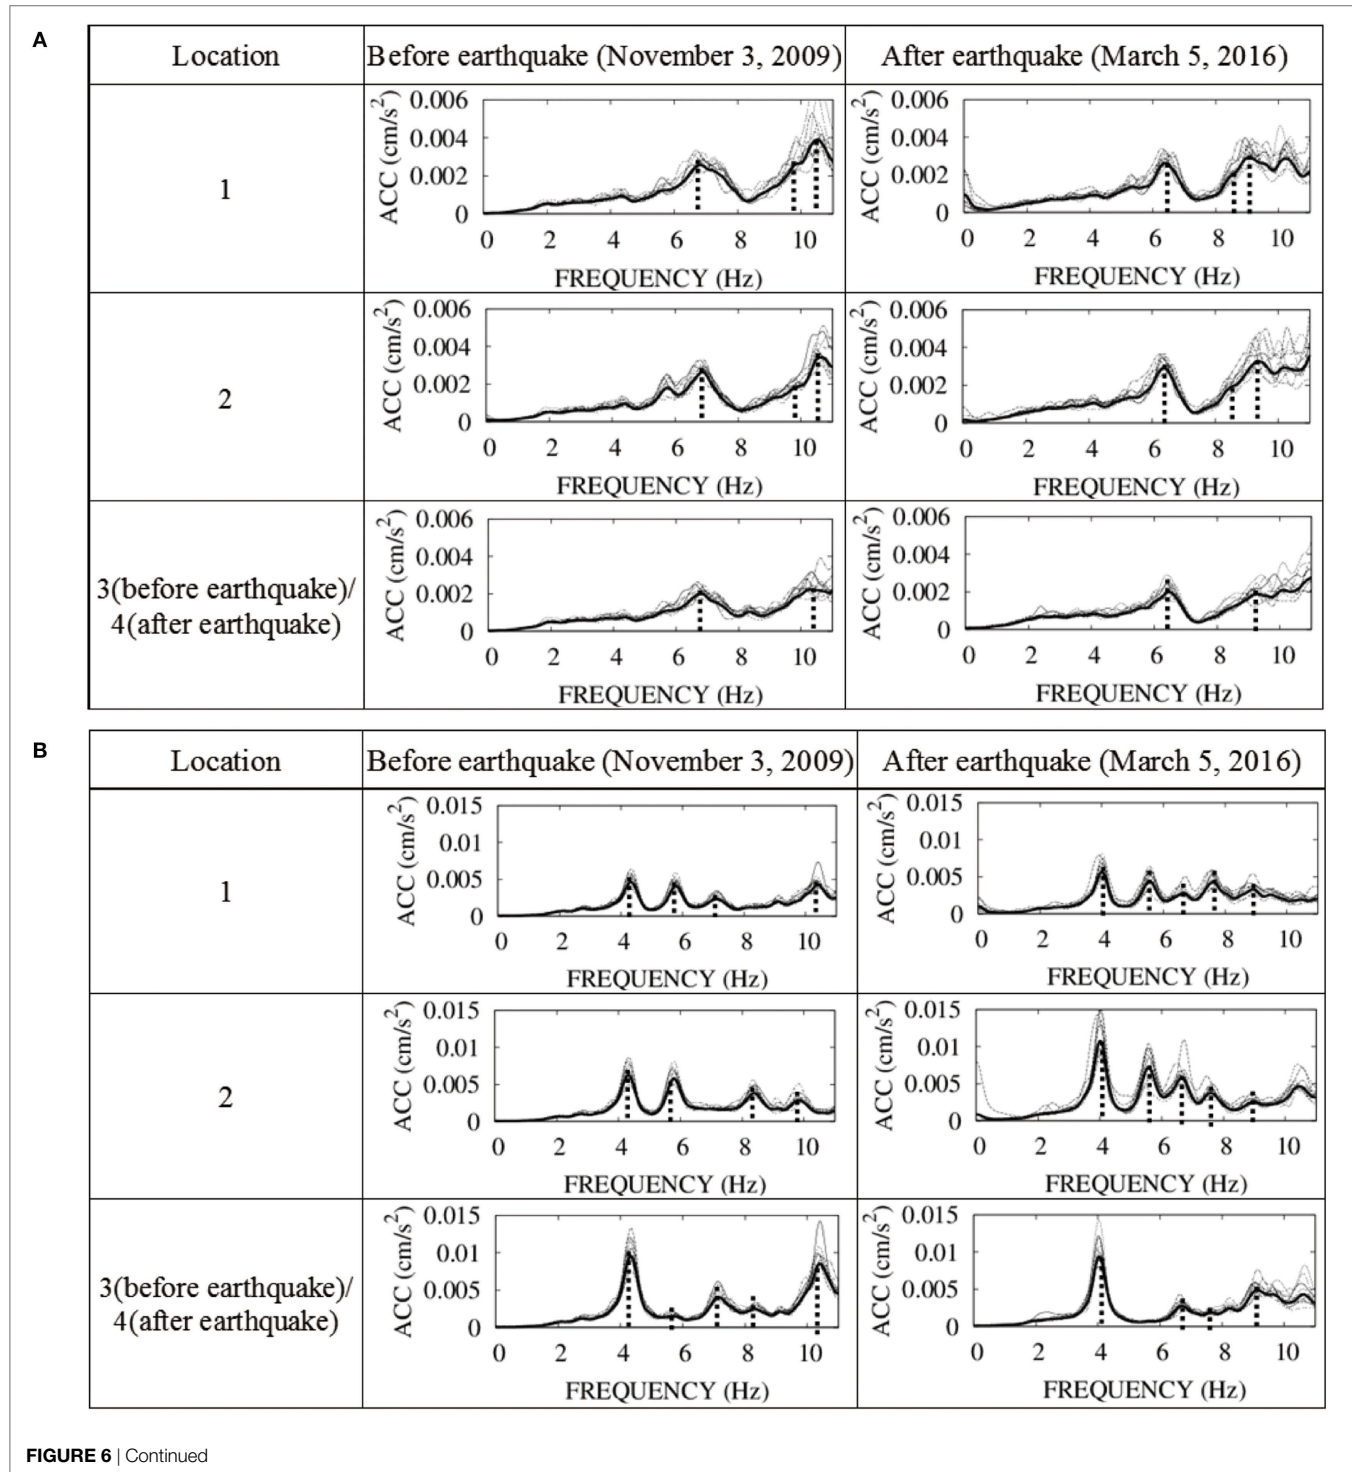
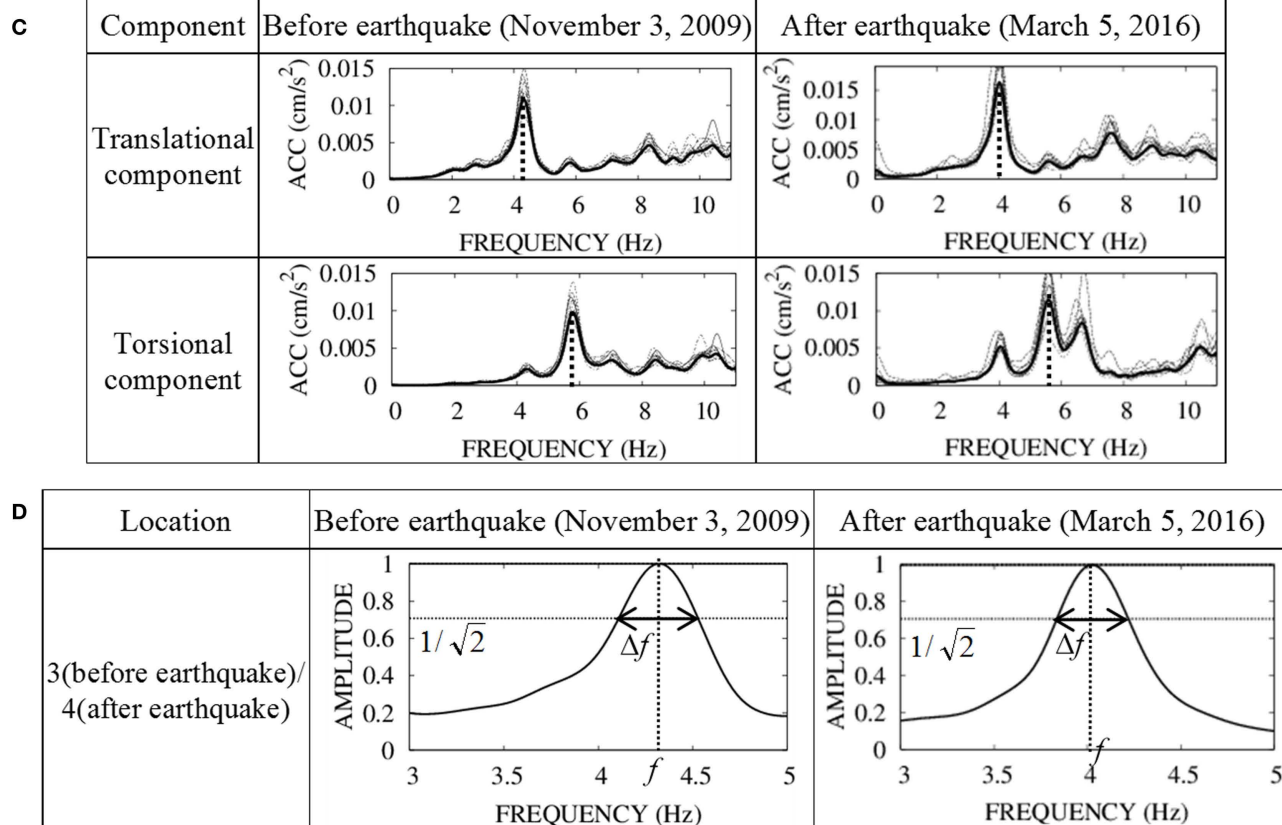
Figure 6A shows a comparison between the Fourier amplitudes of the first-floor responses in the longitudinal (x , NS) direction before and after the earthquake. In **Figure 6A**, peaks can be seen at around 6.87 and 10.5 Hz before the earthquake and 6.43 and 9.2 Hz after the earthquake. It is reasonable to assume that these frequencies correspond to the natural frequencies of the dominant modes in the longitudinal direction before and after the earthquake. A slight peak can also be seen at locations 1 and 2 around 9.7 Hz before the earthquake and 8.5 Hz after the earthquake.

before and after the earthquake. In **Figure 6B**, peaks can be seen at 4.33, 5.78, 7.13, 8.4, and 10.2 Hz before the earthquake and 4.02, 5.58, 6.68, 7.64, and 9.0 Hz after the earthquake. These frequencies are considered to be the natural frequencies of the modes in the transverse direction. A greater number of the peaks can be seen in the Fourier amplitudes of the response in the transverse direction than that in the longitudinal direction. To further understand these details, the responses were separated into the translational and torsional components.

Figure 6C shows the sum and difference of the Fourier amplitudes at locations 1 and 2 in the transverse (y, EW) direction for pre- and post-earthquake measurements. Because the sum and the difference emphasize the translational motion and the torsional motion, respectively, it is found that the natural frequency of the translational motion is 4.33 Hz before the earthquake and 4.02 Hz after the earthquake. It can also be said that the natural frequency of the torsional mode is 5.78 Hz before the earthquake and 5.58 Hz after the earthquake.

The damping ratio of the first transverse mode is calculated by the half-power method under the assumption of white noise excitation. **Figure 6D** shows the normalized Fourier amplitude around the natural frequency of the first transverse mode. The dashed line indicates an amplitude of $1/\sqrt{2}$. The damping ratio h is obtained as $h = \Delta f/2f$ where f is the natural frequency and Δf is the frequency band width shown in **Figure 6D**. The damping ratios before and after the earthquake are found to be 4.82 and 4.85%, respectively.

Comparisons of the natural frequencies of the lowest eight modes and the damping ratios of the first transverse mode are shown in **Tables 1** and **2**. All of the modes indicate the decrease of the natural frequencies by 3.46 to 11.86% after the earthquake. The structural damage due to the earthquake is evidently shown by the stiffness degradation suggested by this result.

Comparison of ambient vibration of the building before and after the 2015 Gorkha earthquake. **(A)** Longitudinal (x, NS) direction. **(B)** Transverse (y, EW) direction. **(C)** Translational and torsional components in the transverse (y, EW) acceleration. **(D)** Damping ratio estimation based on the half-power method.

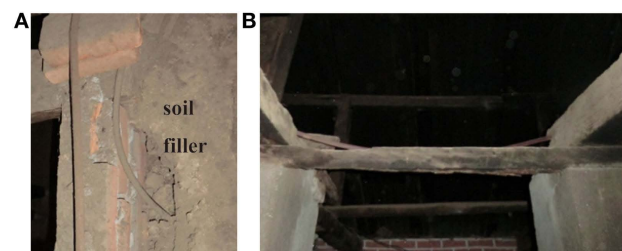
Figure 8A that shows the middle wall on the first floor taken from the above, soil filler can be seen. The timber stiffness also is overestimated, seemingly due to the deterioration of the

material and imperfect connection between members as shown in **Figure 8B**.

FIGURE 8 | Possible reason of overestimate of stiffness parameters. (A) Soil filled inside the brick wall. (B) Deterioration of timbers and imperfect connection.

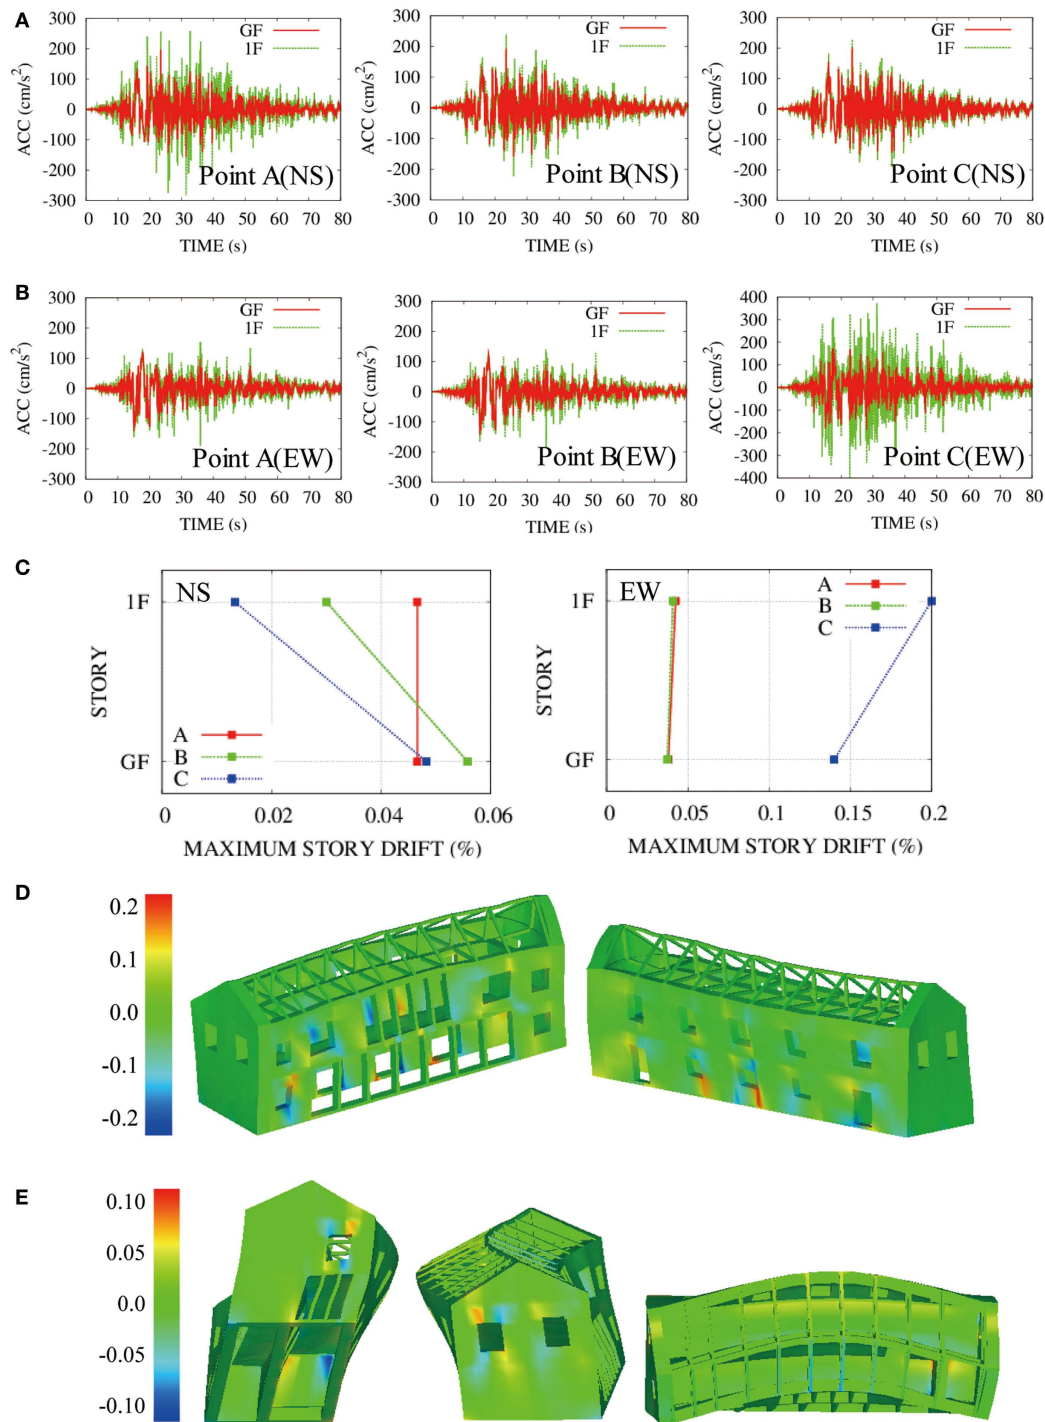
FIGURE 11 | Results of the dynamic analysis. **(A)** Acceleration response in NS direction. **(B)** Acceleration response in EW direction. **(C)** Maximum story drift. **(D)** Shear strain distribution in the xz-plane at 26 s. **(E)** Shear strain distribution in the yz-plane at 29 s.

On the other hand, when the building deformation is in the y direction, significant shear strain of yz -component is observed near the corner of openings in the short side walls as shown in **Figure 11E**. It is noteworthy that considerable shear strain takes place on both sides of the partition walls on the GF and at the intersection of two inner walls. These parts coincide

It is found that the lateral out-of-plane vibration at the center of the long side wall is significant for the both acceleration response and story drift.

The location of structural damage found in the post-earthquake inspection is successfully explained by the shear strain distribution.
